Uniform Mitigation Verification Inspection Form

Question 3: Roof Deck Attachment

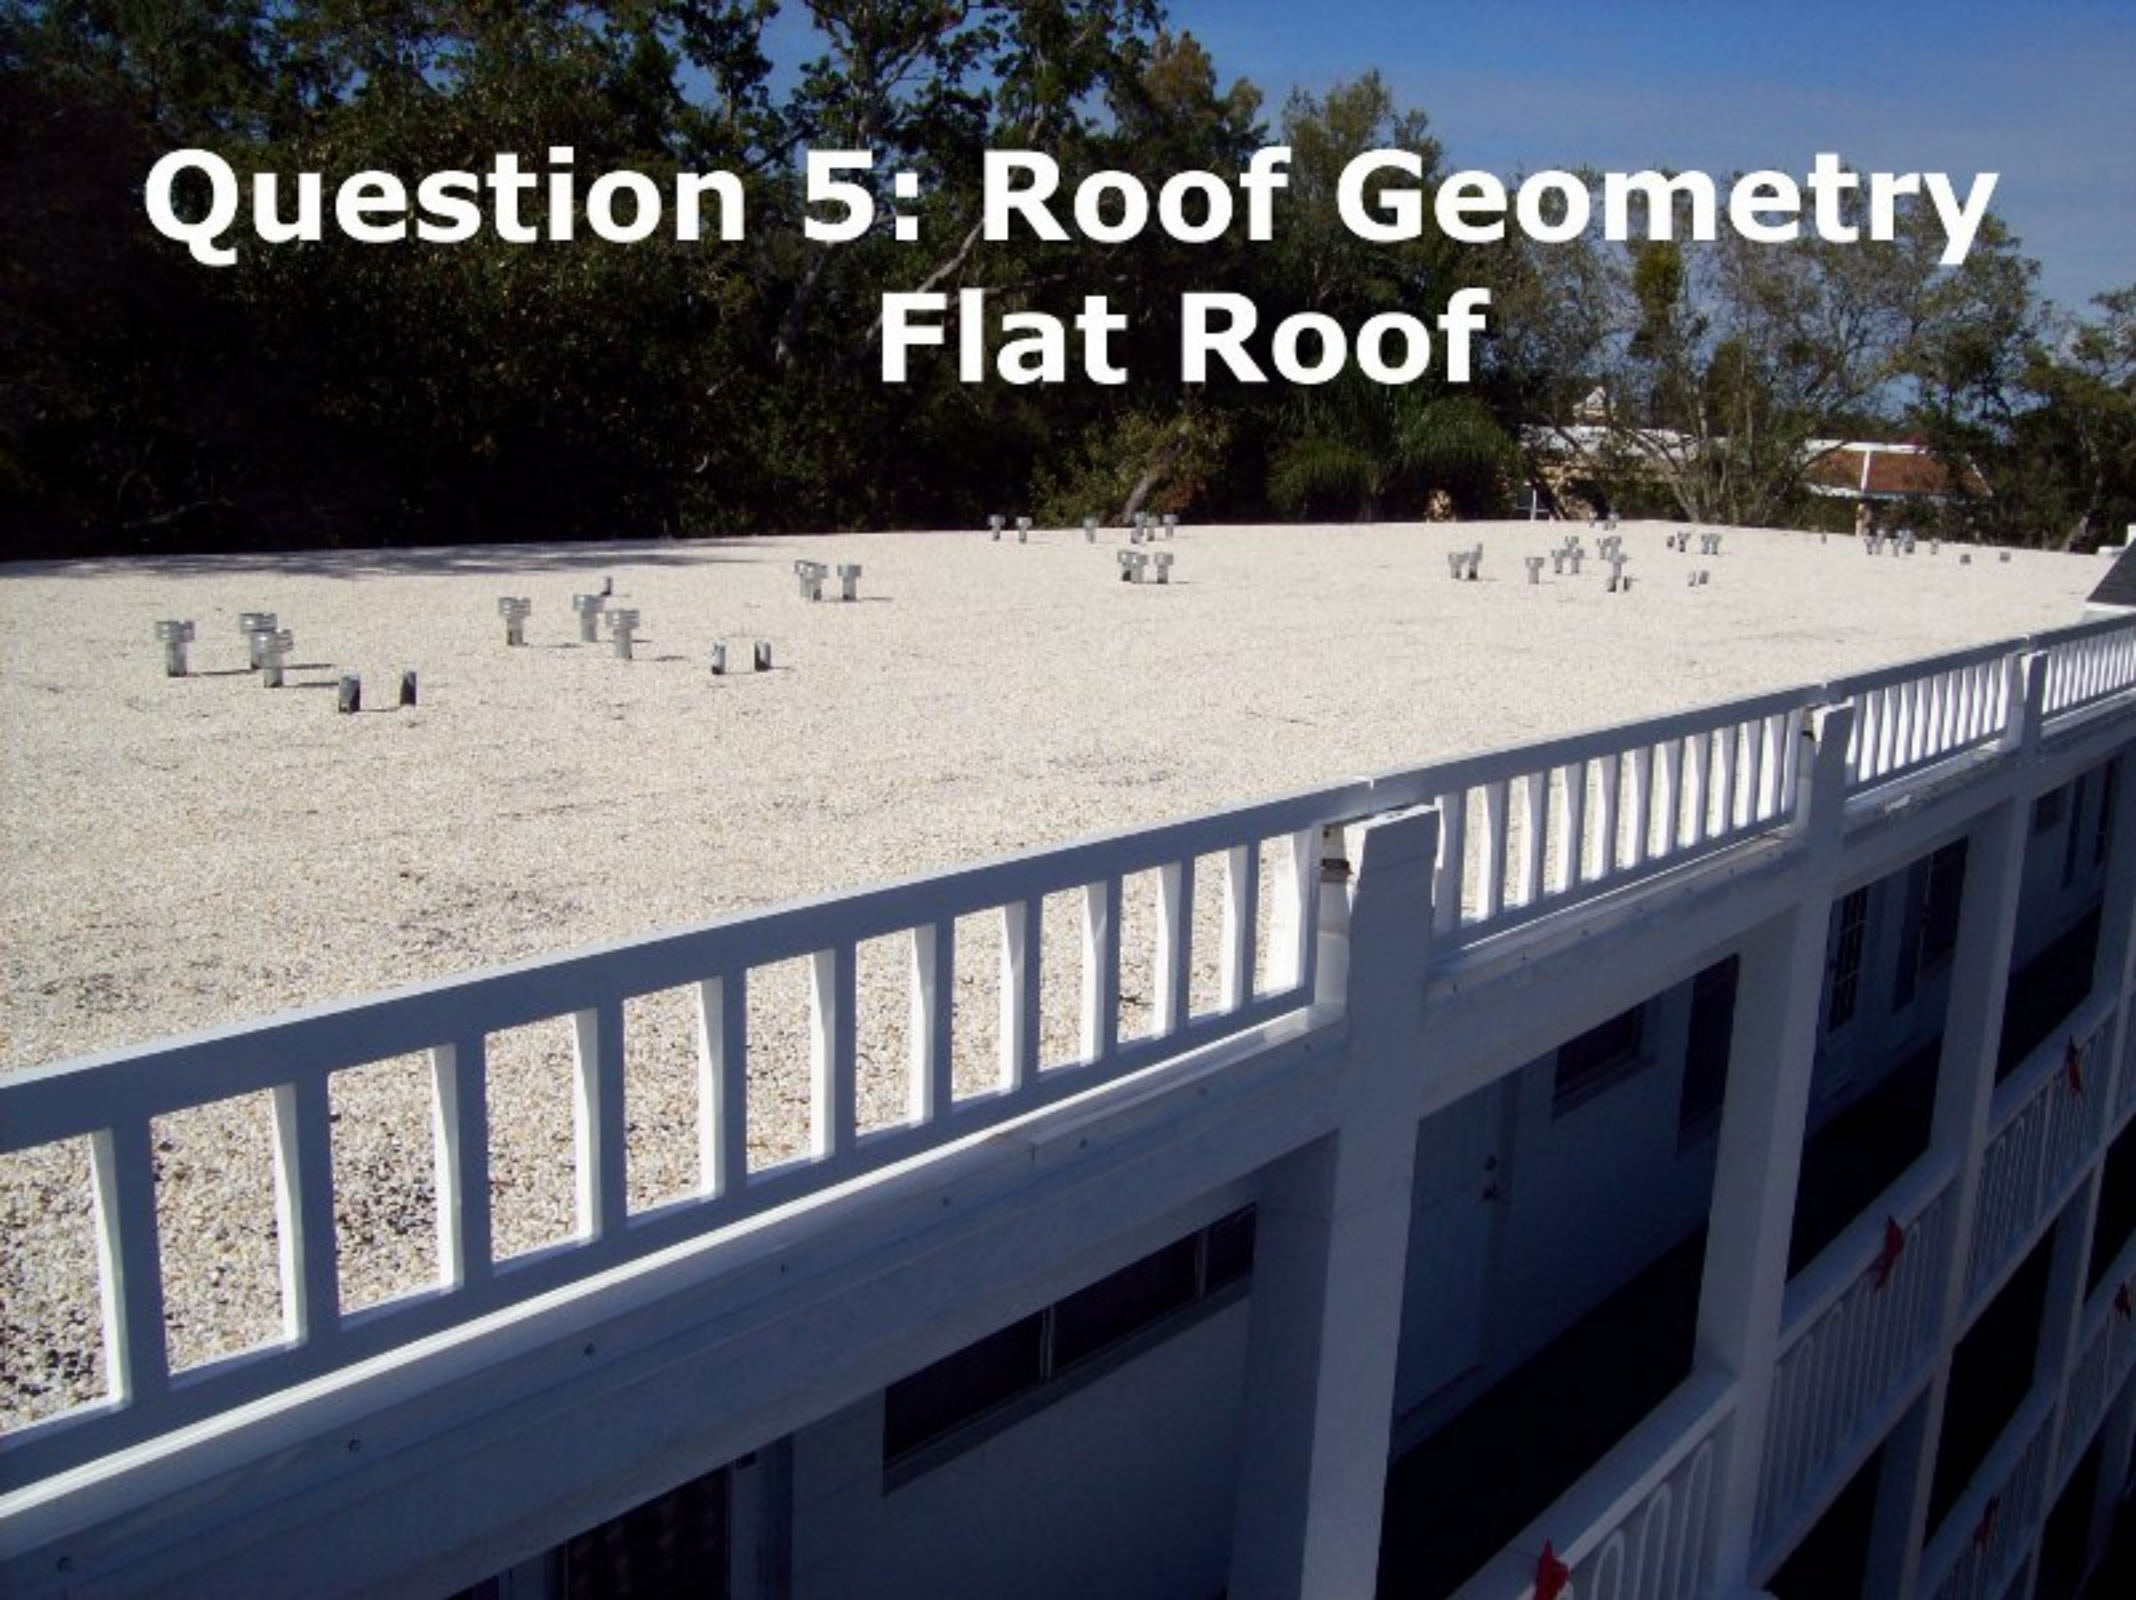
Question 5: Roof Geometry

5. **Roof Geometry:** What is the roof shape? (Do not consider roofs of porches or carports that are attached only to the fascia or wall of the host structure over unenclosed space in the determination of roof perimeter or roof area for roof geometry classification).

- ☐ A. Hip Roof Hip roof with no other roof shapes greater than 10% of the total roof system perimeter.
Total length of non-hip features: _____ feet; Total roof system perimeter: _____ feet
- ☐ B. Flat Roof Roof on a building with 5 or more units where at least 90% of the main roof area has a roof slope of less than 2:12. Roof area with slope less than 2:12 _____ sq ft; Total roof area _____ sq ft
- ☐ C. Other Roof Any roof that does not qualify as either (A) or (B) above.

Flat Roof
